PRODUCT INFORMATION BULLETIN

Bulletin Number : **PIB-01-2017**

Subject : **VIGIL CUTTER DEFORMATION**

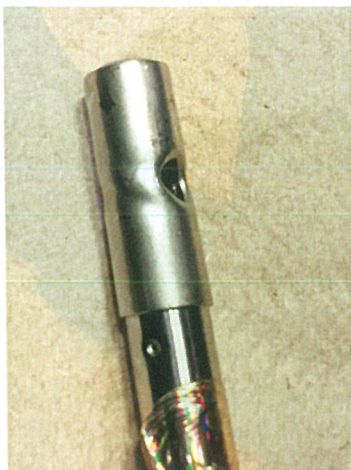
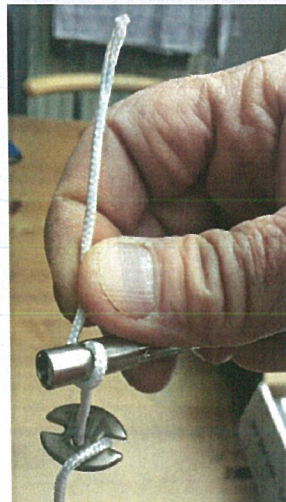
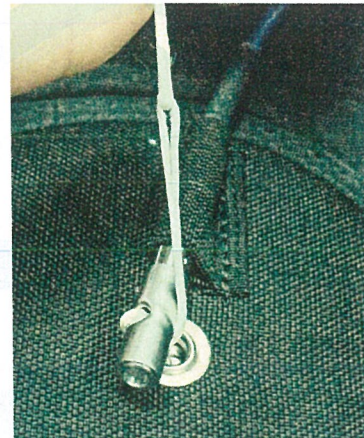
We recently have found a few cutters in the field that showed clear indentation marks around or near the reserve-loop hole on the cutter sleeve.

Upon further investigation and after conducting numerous tests during reserve container closures, we have discovered that these indentations are caused when the reserve loop has been routed incorrectly when using a skydiving harness/container where the AAD cutter is placed on top of the floor plate at the bottom of the container.

By doing so, the useable length of the reserve closing loop will obviously be much shorter than the manufacturer's recommendation and in most cases this misrouting won't be visible once the reserve freebag has been placed on top.

We, AAD, nv / Vigil America, Inc, do not advice against the use of these tools but strongly recommend to verify the correct routing of the reserve loop before closing the reserve container.

It is strongly advised that ALL VIGIL CUTTER UNITS that are or were previously installed in a harness container system where the cutter is placed at the bottom of the reserve tray against the floor plate and that clearly show these type of indentations, should be sent back to AAD or Vigil America for inspection and consequently a possible replacement.

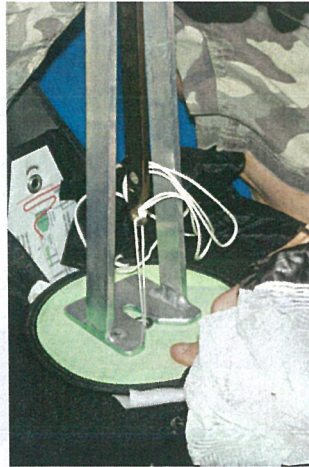
The damage to the cutter sleeve therefore also occurs when using a packing/closing tool that provides extra noticeable leverage and ease of closing. The use of these tools are pretty popular amongst parachute riggers and demand less physical strength and effort to close but do not provide any feedback of actual pull force being used or need in order to close the container.

When the reserve container is being closed without the use of any leverage tools, it becomes pretty obvious that the required loop length is insufficient and therefore probably misrouted.
