## **Product Service Bulletin**

**Bulletin Number:** PSB-5

**Subject:** Vigil Cutters type 3

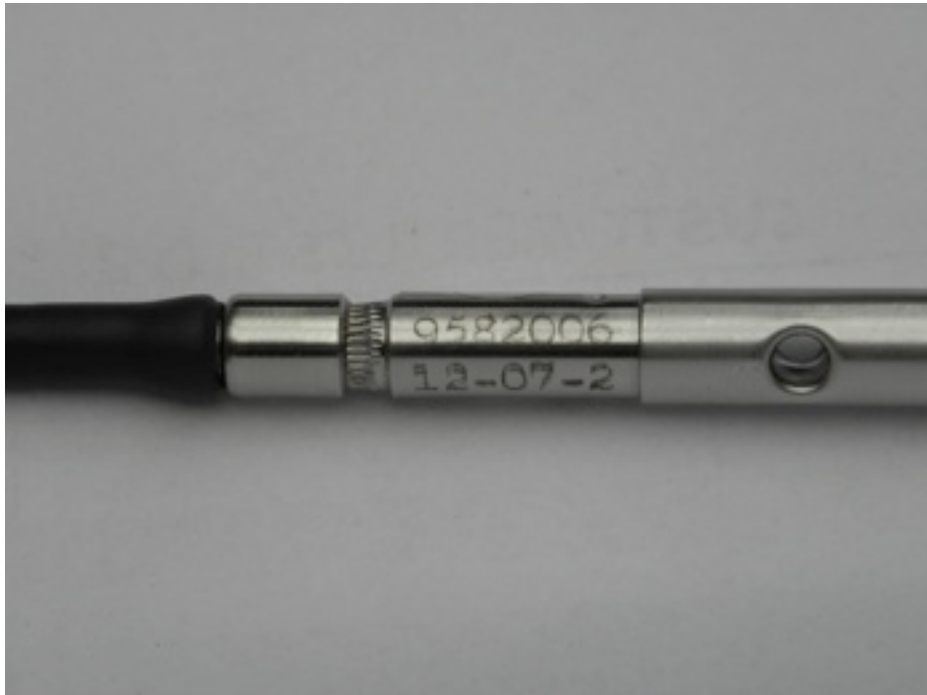
Picture 1

After an activation of the cutter, the cutter body separated from its base.  
This occurred on the 19th September 2009 in Cerfontaine (Belgium).

Following notification by AAD of this incident to our cutter manufacturer, we were informed that this incident was caused by an error during the final crimping of the cutter body to its base.

This permitted the internal pressure to move the detonator and its base backwards, instead of pushing the cutter knife forward.

With this scenario, the knife was not able to do its job and stayed in its original position without cutting the closing loop.

**In the interest of safety, AAD has decided to recall all cutters from this batch and to replace all those cutters free of charge.**

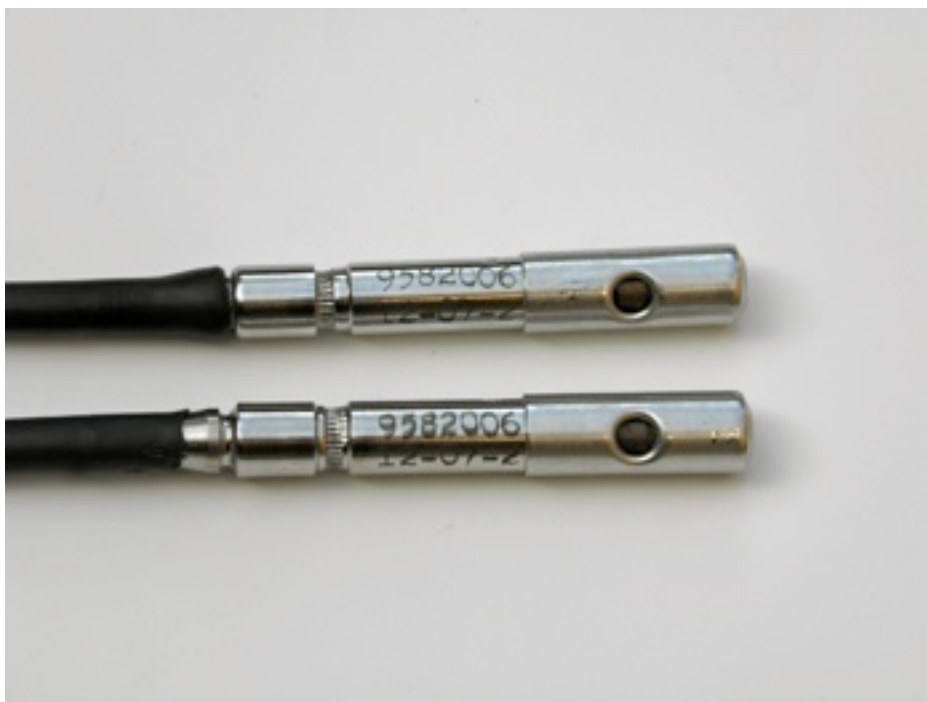
Picture 2

We want to confirm that 2 cutters of that batch were activated by us for test purpose and worked to specification. (See picture 2).
